# Manhole Inspection Summary

Manhole # S29UU1002MH

Insp Date: **3/29/07 10:56 AM**

**Location** Address: **300 WYNDHURST AVE**

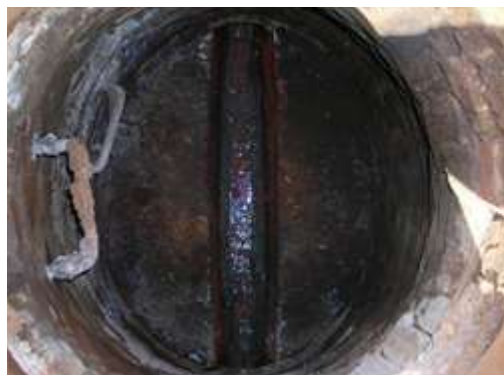
Top View

Corroded steps. Evidence of surcharge - Bench debris.

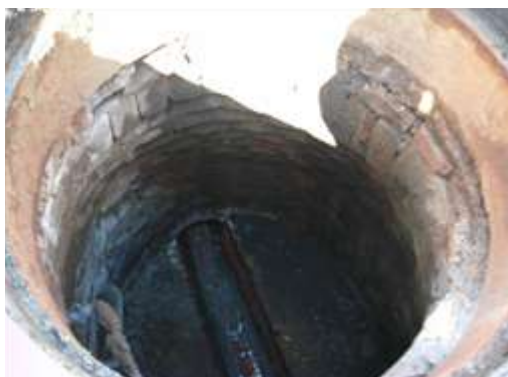
Defect

Frame leaks. Frame offset. Adjustrment deterioration, loose brick and infiltration. Corbel and Barrel infiltration - other side.

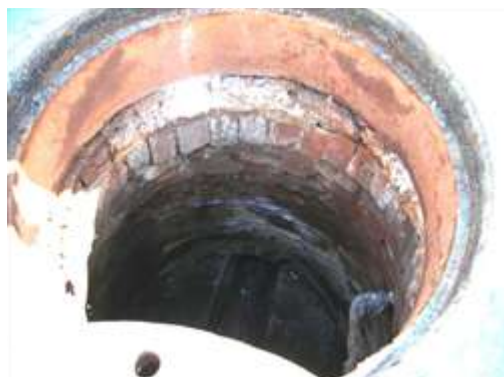
Defect

Frame leaks. Frame offset. Adjustrment deterioration, loose brick and infiltration. Corbel and Barrel infiltration.

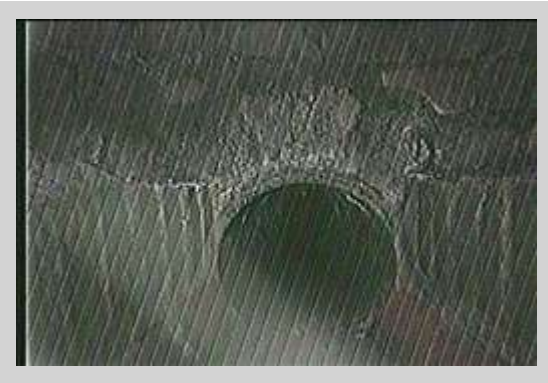
### 8 in. Circular Gravity Sewer Pipe Out @ 12 O'Clock

Pipe Material: **Clay** ☐ Pipe Lined

Invert Depth: **6.22** (ft.) Flow Characteristics: **Fast**

Deposits: ☒ None ☐ Mud ☐ Sludge ☐ Debris ☐ Grease

Infiltration: **None** Pipe Seal Cond: **Unknown**

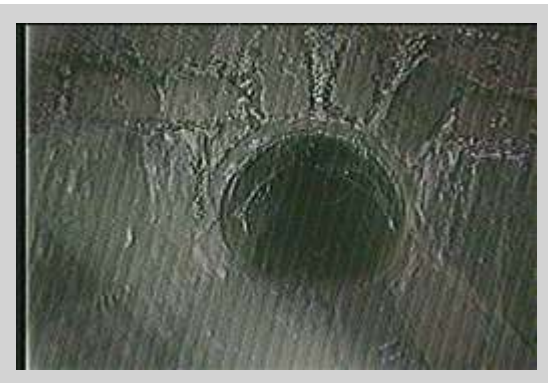
### 8 in. Circular Gravity Sewer Pipe In @ 6 O'Clock

Pipe Material: **Clay** ☐ Pipe Lined

Invert Depth: **6.07** (ft.) Flow Characteristics: **Fast**

Deposits: ☒ None ☐ Mud ☐ Sludge ☐ Debris ☐ Grease

Infiltration: **None** Pipe Seal Cond: **Unknown**
